MINISTRY OF TRANSPORT AND CIVIL AVIATION

REPORT ON THE COLLISION

8th March 1958

CHINLEY

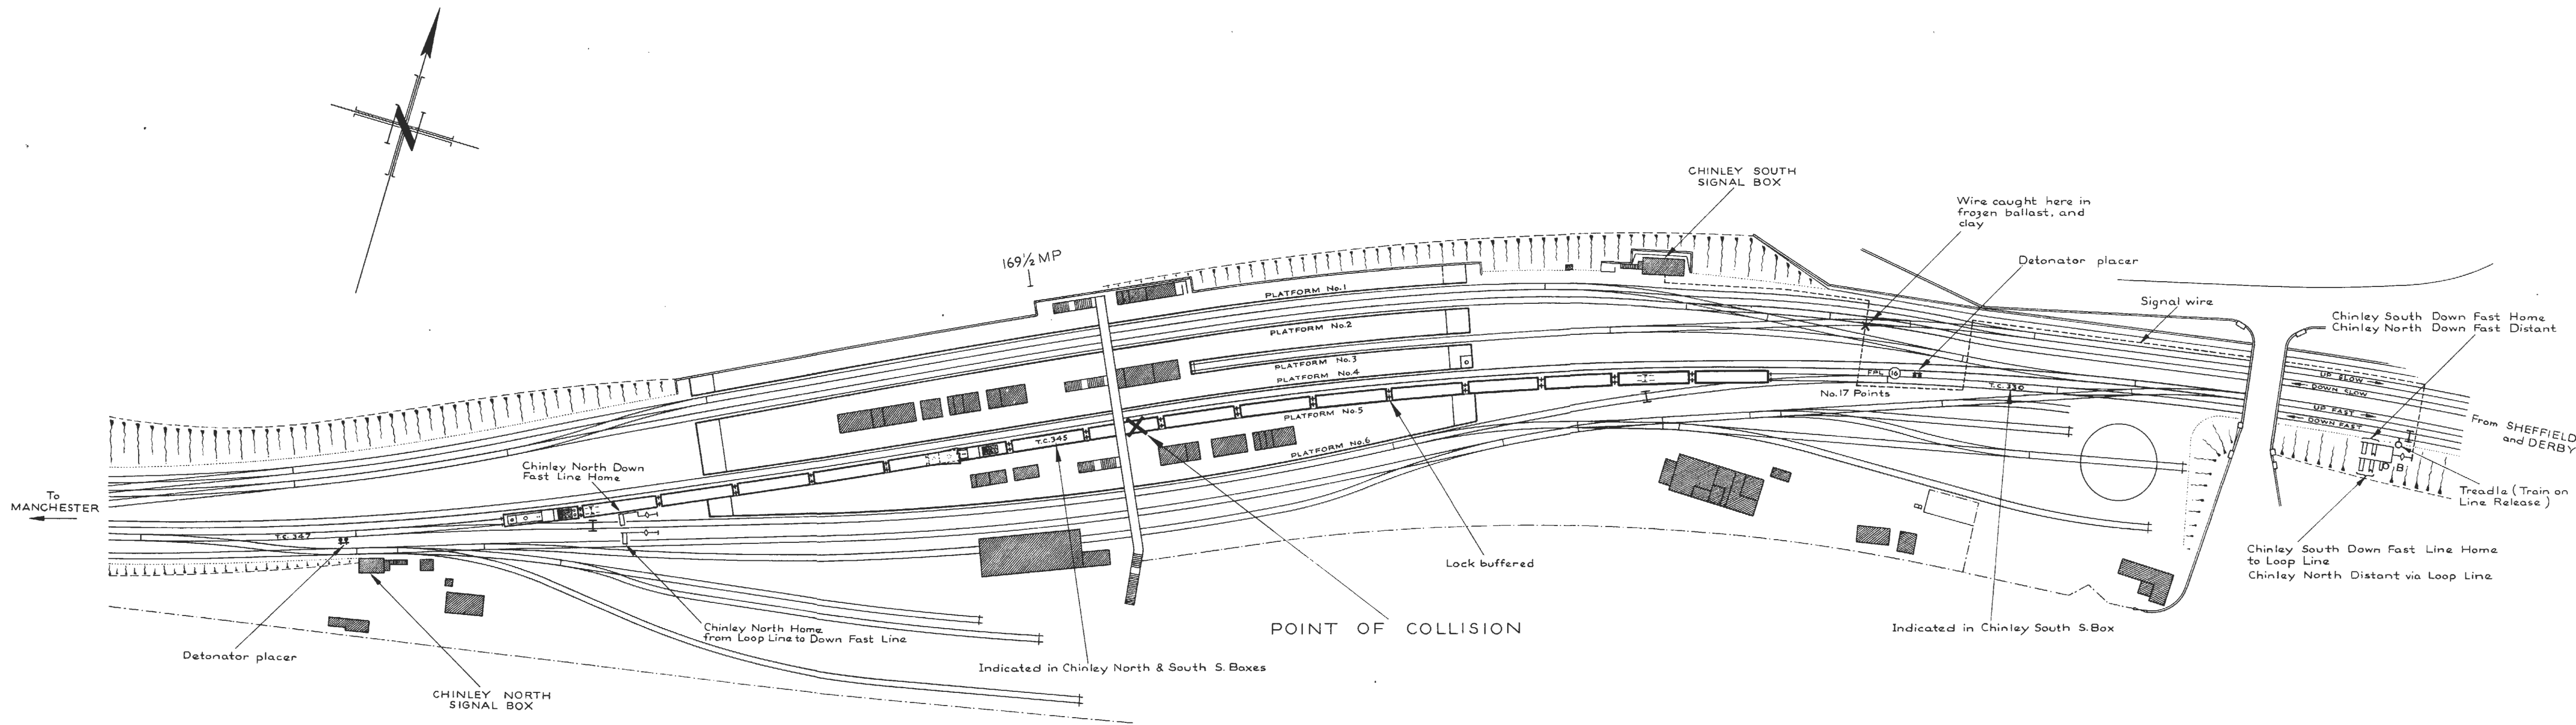
# COLLISION AT CHINLEY STATION

3. The plan shows the general arrangement of the tracks through Chinley station, and the relevant signals. The gradient is falling steeply at 1 in 90 towards Chinley in the Down direction, in which the trains were running, but it eases to 1 in 220 through the station. There are three signal boxes to which reference will be made in the report; they are Chinley North Junction signal box about 1 mile in the Up direction from Chinley station, where the routes from Derby and Sheffield converge to form the 4-track route through Chinley, Chinley Station South Junction signal box at the Up end of the station, and Chinley Station North Junction signal box 346 yards away at the Down end of the station. The collision occurred near the middle of the station about 140 yards beyond Chinley Station South box. I propose to refer to these signal boxes as Chinley Junction, Chinley South, and Chinley North boxes respectively. The boxes are of usual construction, mainly wood, with an elevated working floor and an illuminated diagram above the lever frame.

Down Fast line lead, one along the main line past No. 5 platform in Chinley station which was the route followed by both trains, and the other via points No. 17 to the loop past No. 6 platform. They are upper quadrant semaphores and are placed fairly high on a bracketted post so that they are in good view above a road overbridge from the signal box which is about 200 yards away. There is a sodium vapour street lamp at one end of the overbridge, which is alight from dusk until about 11 p.m., and which gives sufficient light for the signalman to see the arms of these signals at night if he looks with care. The back lights on the signals can also be seen clearly from the box except, of course, in fog.

5. Underneath the two home signals there are the distant signals worked from Chinley North box; these are slotted with the home signals. There is also a subsidiary signal on the bracket post for the loop line.
